ANNUAL REPORT FOR 2013

# Annual Ambient Air Quality Monitoring and Dispersion Modelling

Richards Bay Clean Air Association (RBCAA)  
Sandy Camminga

**Report Number.** 12614846-12632-17

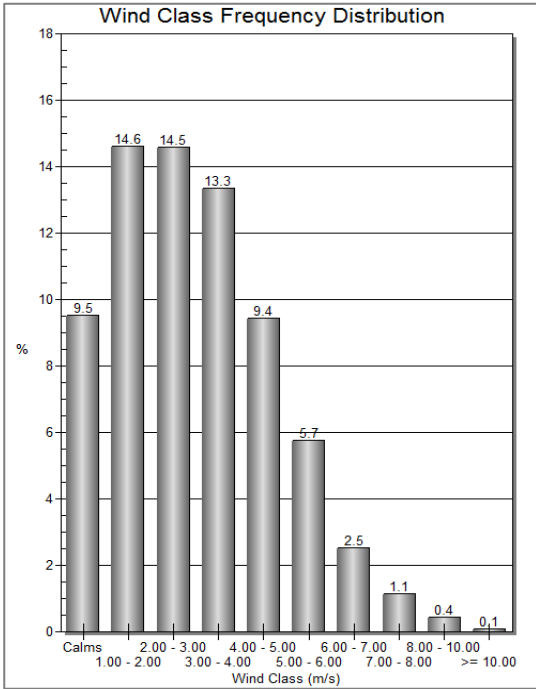
Figure 4: Arboretum wind class frequency distribution for 2012

In 2012 the average wind speed was 2.85m/s, with 9.49% calms (Figure 4). The average wind speed in 2013 was 3.54m/s with 1.56% calms (Figure 5). Arboretum measured approximately 8% more calms in 2012 than in 2011 this may be as a result of a slightly worn bearing on the wind speed indicator during 2012. This is evident when comparing records from Harbour West which indicate 3.93% calms in 2012 and 3.75% calms in 2013.

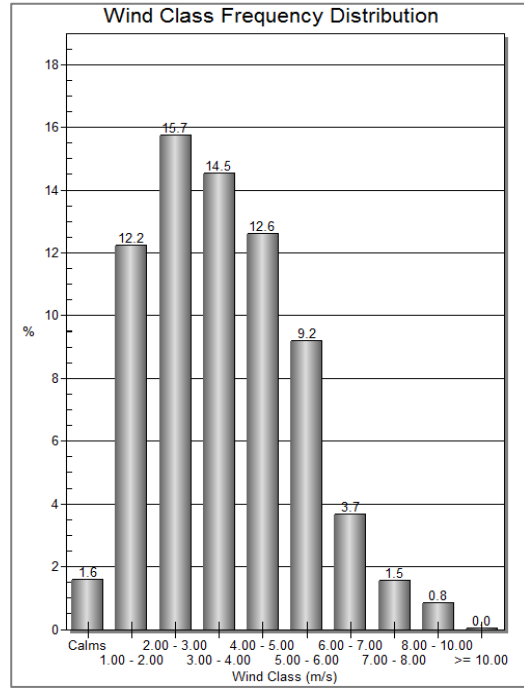
Figure 5: Arboretum wind class frequency distribution for 2013

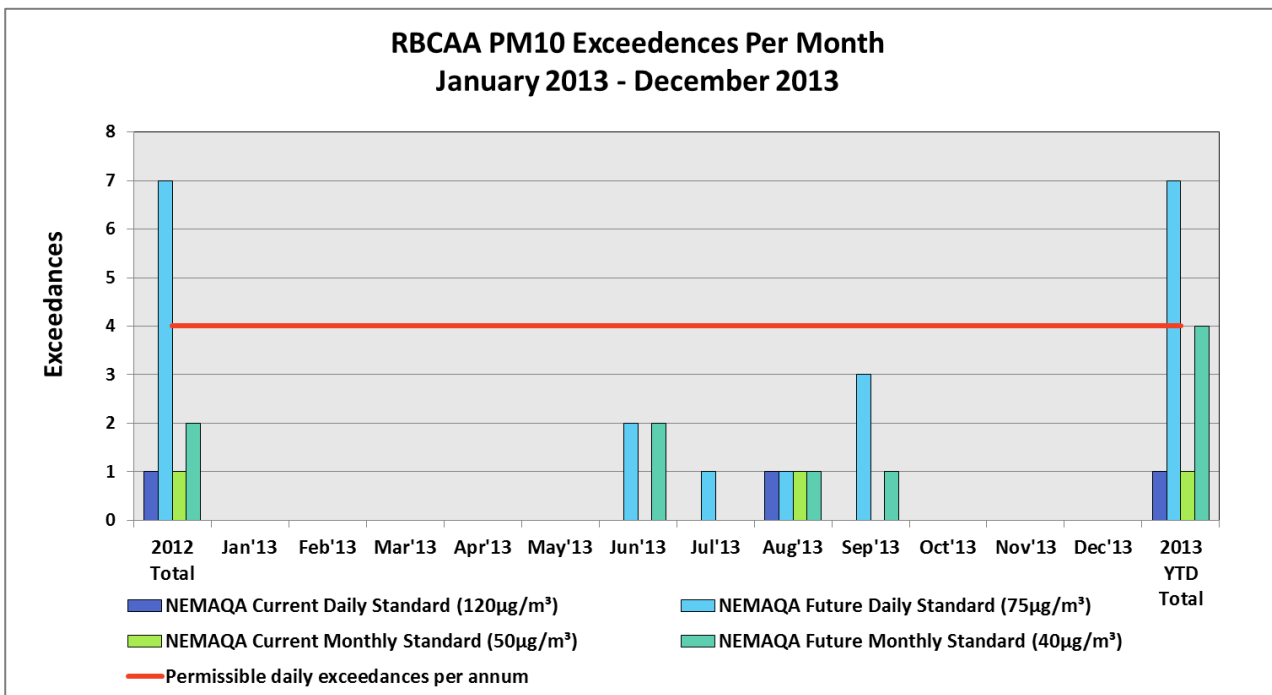
Figure 12: PM<sub>10</sub> exceedances of the current and future standards.

Figure 12 indicates the number of exceedances recorded in 2013 in comparison with 2012.

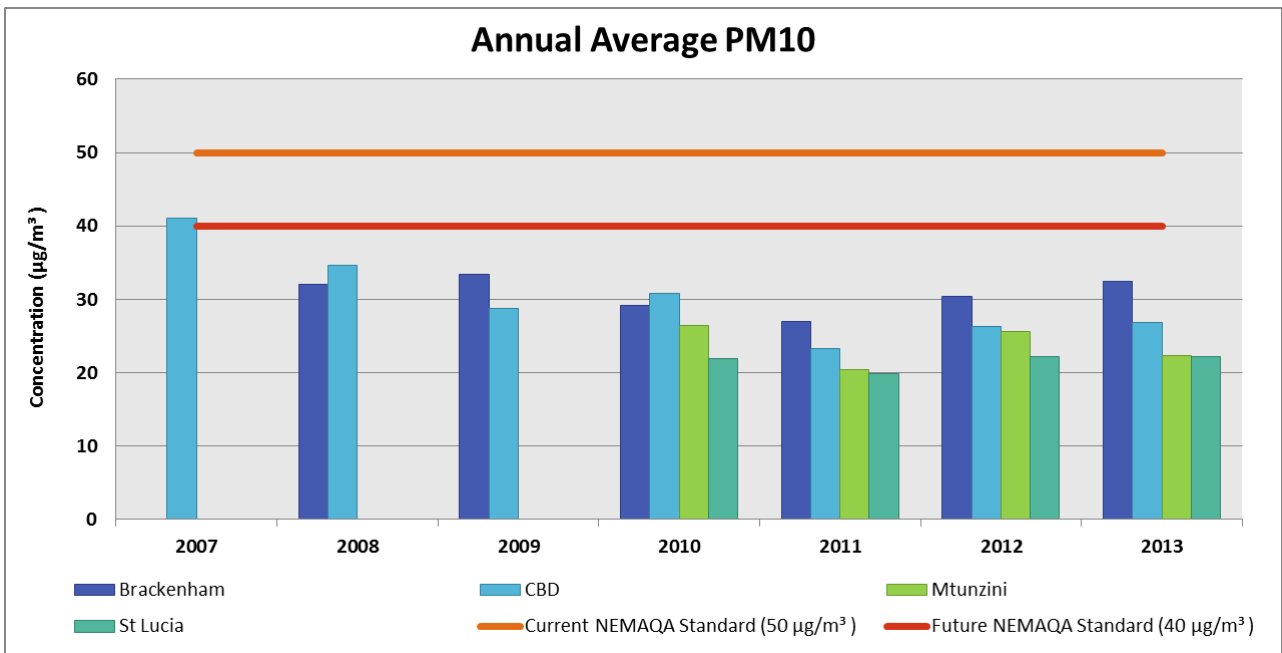
Figure 13: Annual average PM10 concentrations.

Annual average concentrations dating back to 2007 are illustrated in Figure 13. An over-all decreasing trend is noticeable over the seven year period; however 2013 annual average concentrations are higher at Brackenhams and CBD than those recorded in 2012.

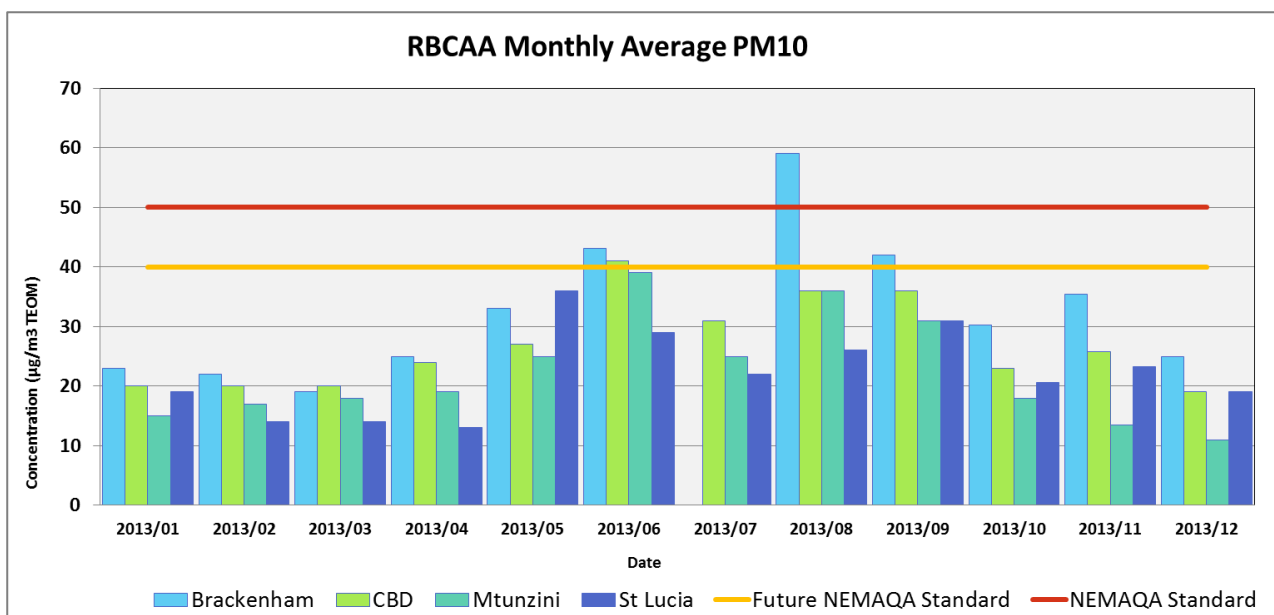
Figure 14: Seasonal trends in PM<sub>10</sub> (monthly average concentrations)

The seasonal trends in PM<sub>10</sub> concentrations for 2013 are provided in Figure 14.

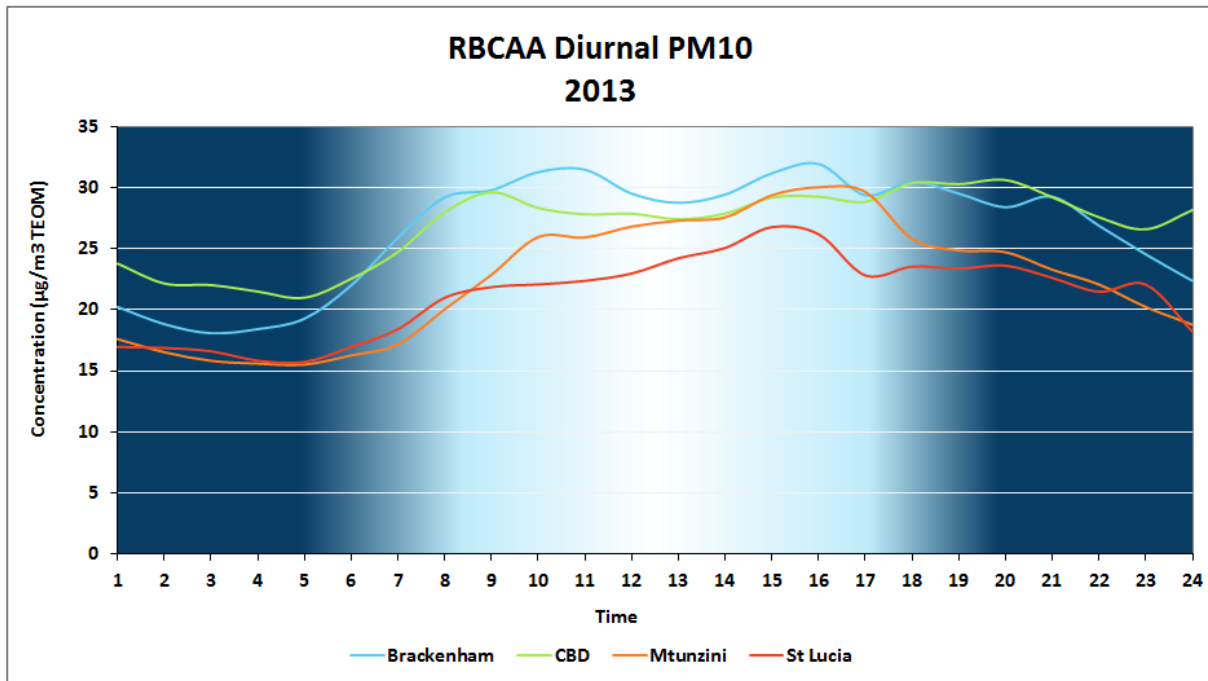
Figure 15: PM<sub>10</sub> diurnal trend

Diurnal PM<sub>10</sub> concentrations are shown below (Figure 15).

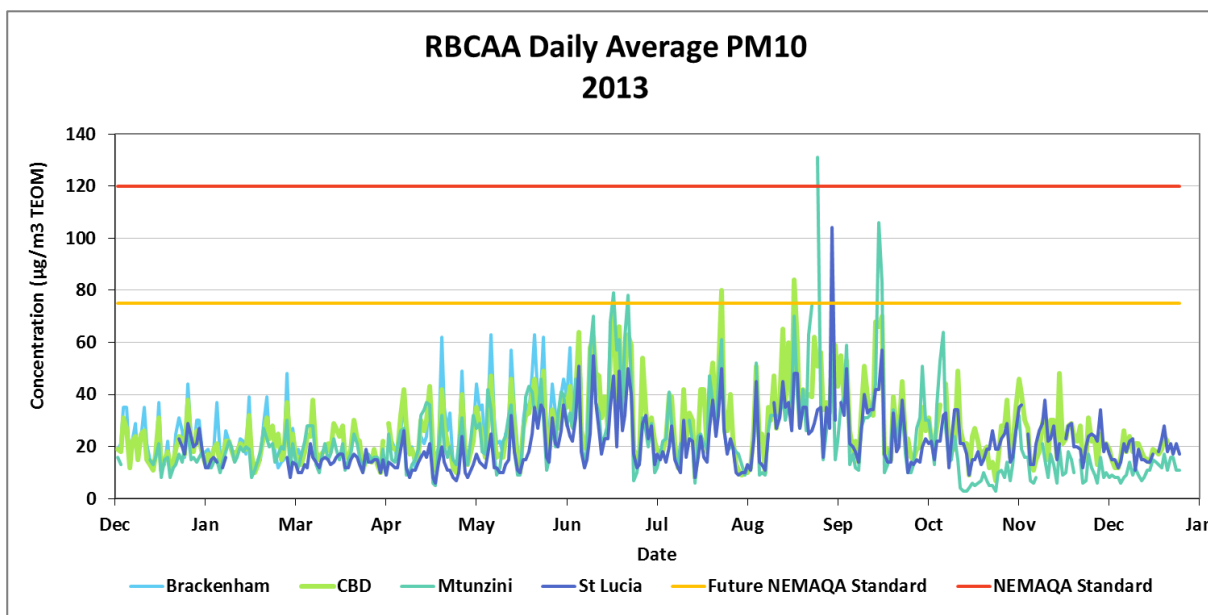
Figure 16: PM<sub>10</sub> daily average concentrations

The daily average PM<sub>10</sub> concentrations are shown below (Figure 16).

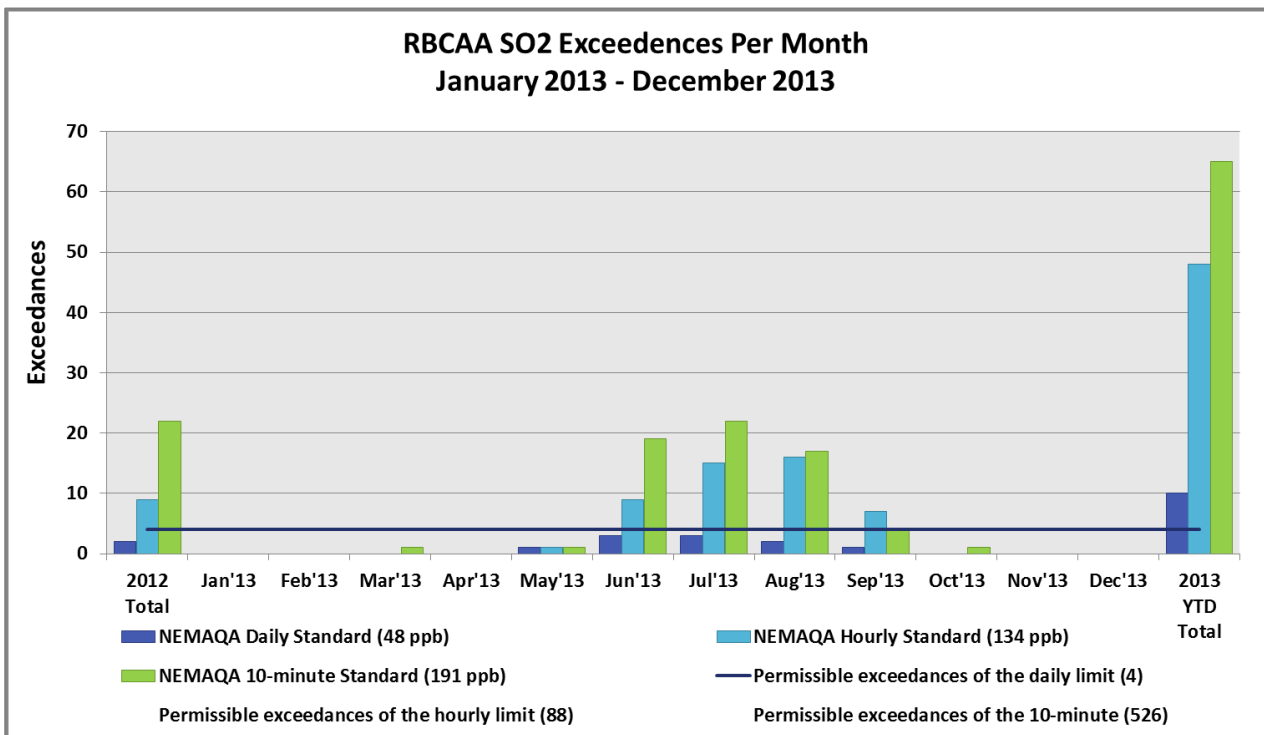
Figure 17: SO<sub>2</sub> exceedances recorded in 2013

Ten (10) exceedances of the NEMAQA daily average standard (48ppb), forty eight (48) exceedances of the NEMAQA hourly average standard (134ppb) and sixty six (66) exceedances of the NEMAQA 10 minute average standard (191ppb) were recorded during 2013 (Figure 17). All exceedances were recorded at the Scorpio Station, with the exception of one (1) which was recorded at Harbour West.

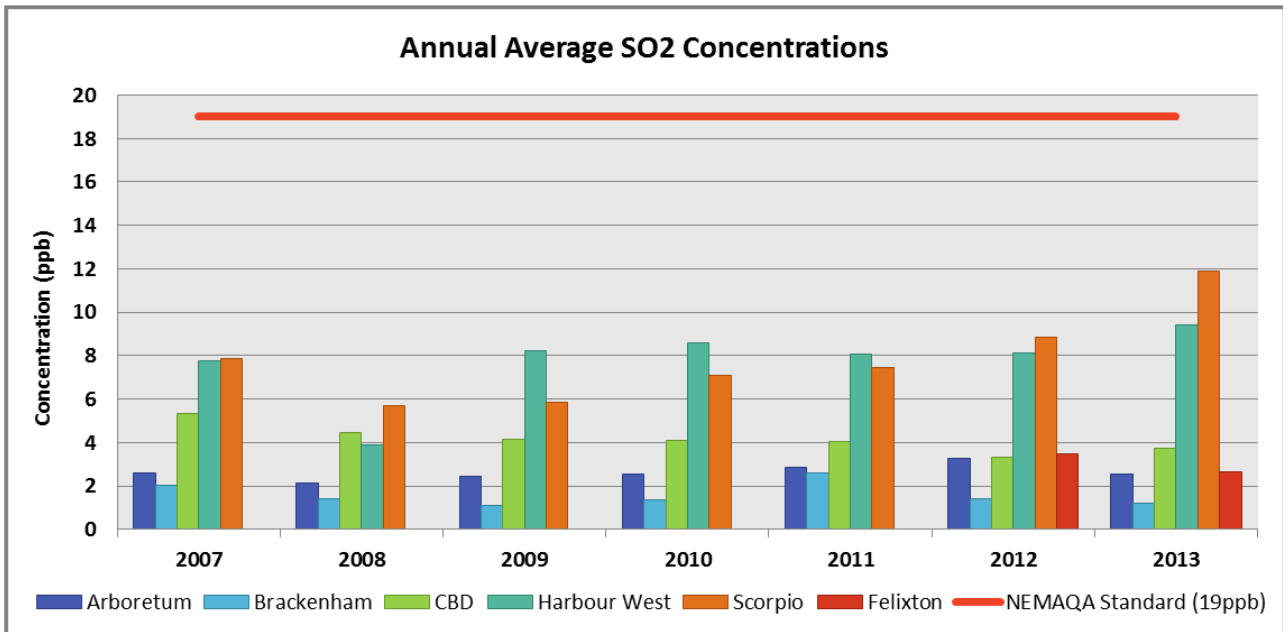
Figure 18: Inter-annual average SO<sub>2</sub> concentrations.

Annual average SO<sub>2</sub> concentrations are illustrated in Figure 18. A marked increase in average annual SO<sub>2</sub> concentrations is evident at Scorpio over the seven year period. Harbour West displays a similar trend although to a lesser extent. The NEMAQA Annual average standard (19ppb) was not exceeded during 2013.

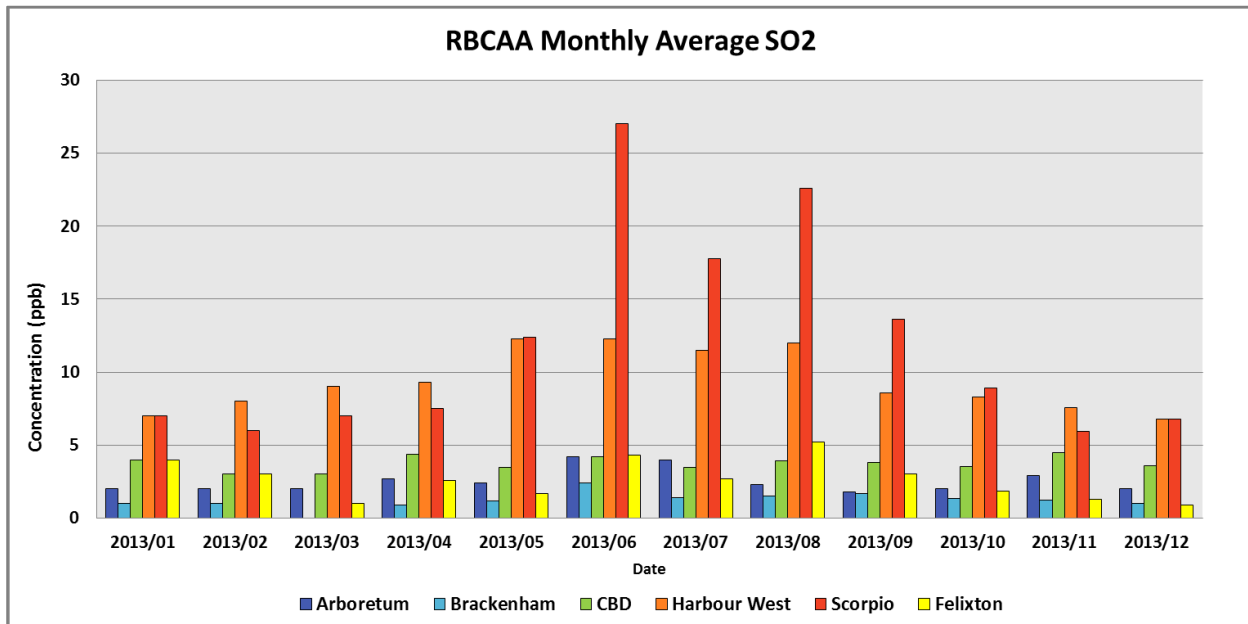
Figure 19: Seasonal trends in SO<sub>2</sub> (monthly average concentrations)

The seasonal trends in SO<sub>2</sub> concentrations for 2013 are provided in Figure 19.

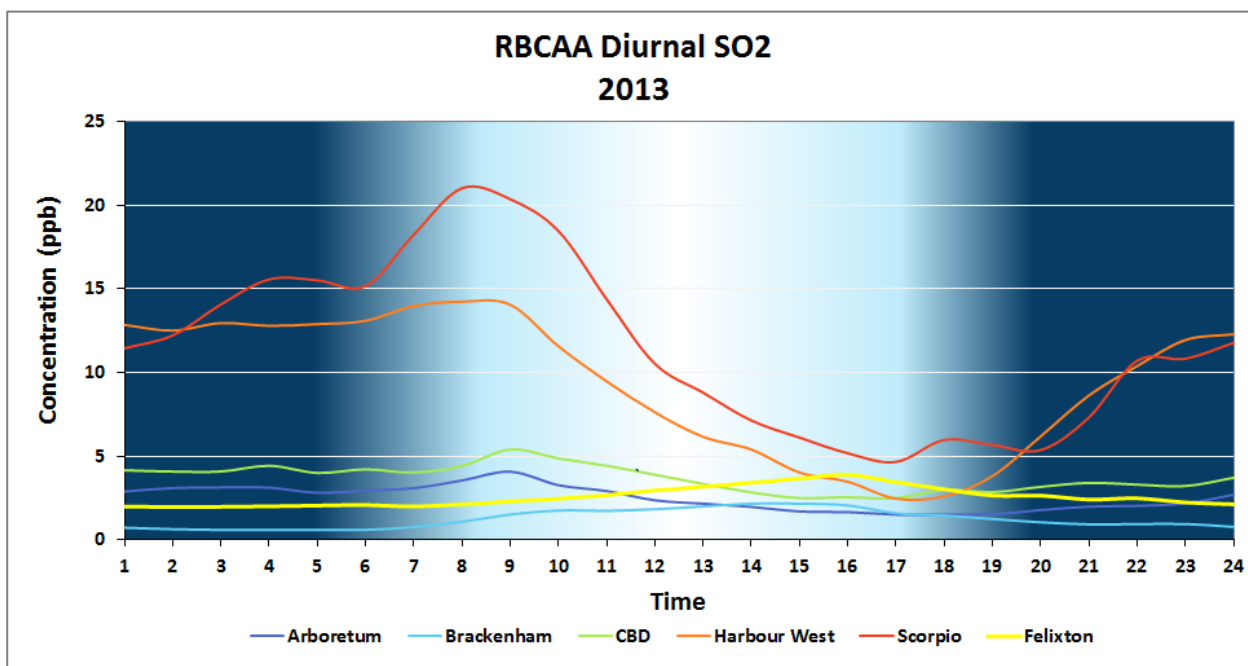
Figure 20: SO<sub>2</sub> diurnal trend

Diurnal SO<sub>2</sub> concentrations are shown below (Figure 20).

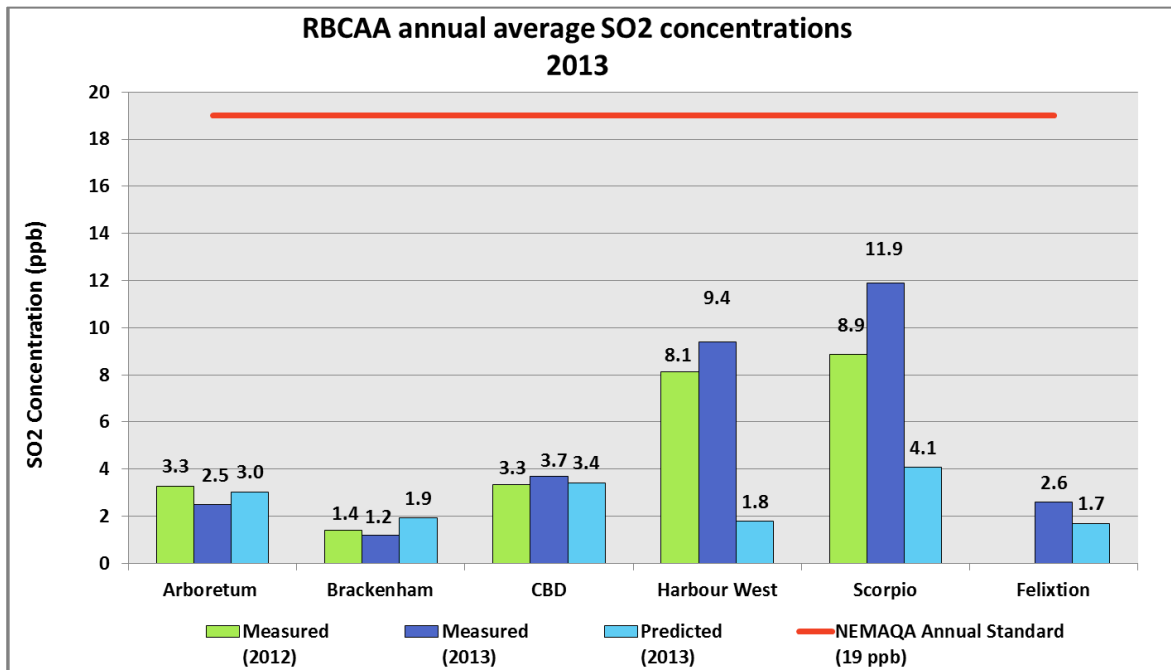
Figure 21: Annual average SO<sub>2</sub> concentration and prediction

Note: Under predictions may indicate higher than normal emissions for the time period concerned.

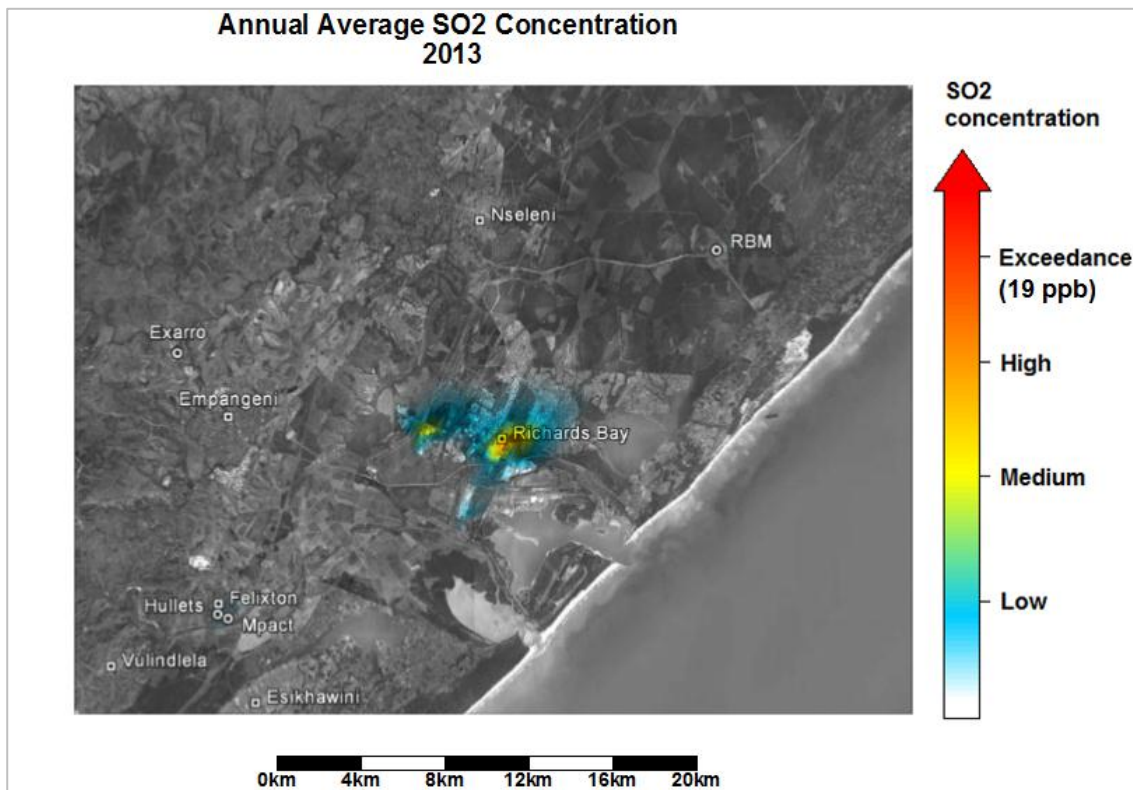
Figure 22: Maximum predicted annual average SO<sub>2</sub> concentration (regional map)

- Regional (Figure 22);
- Richards Bay (Figure 29);
- Felixton (Figure 30); and
- RBM (Figure 31).

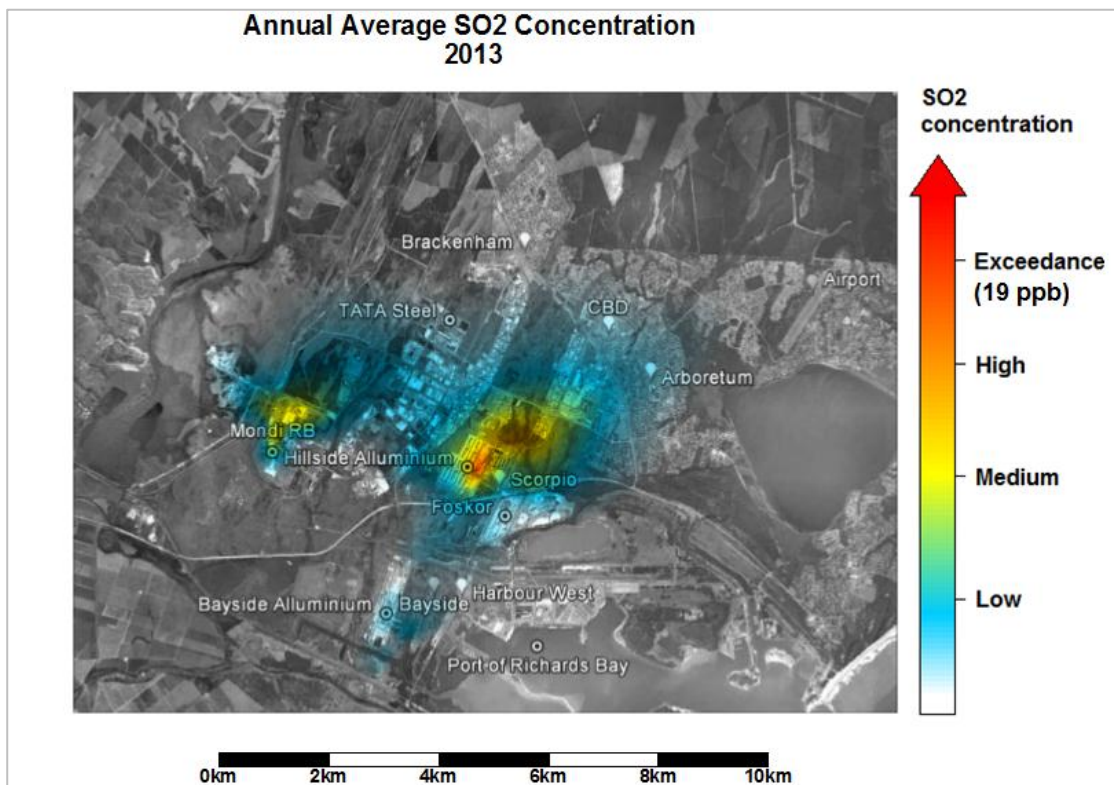
Figure 23: Maximum predicted annual average SO<sub>2</sub> concentration (Richards Bay map)

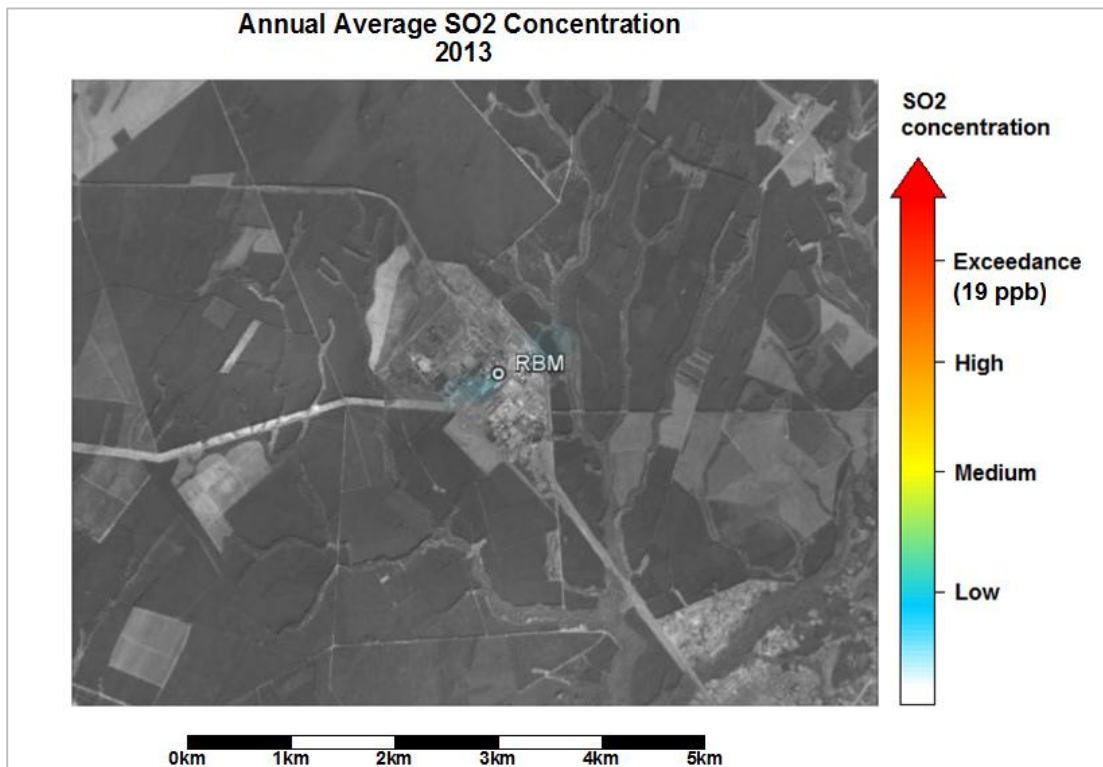
Figure 25: Maximum predicted annual average SO<sub>2</sub> concentration (RBM map)

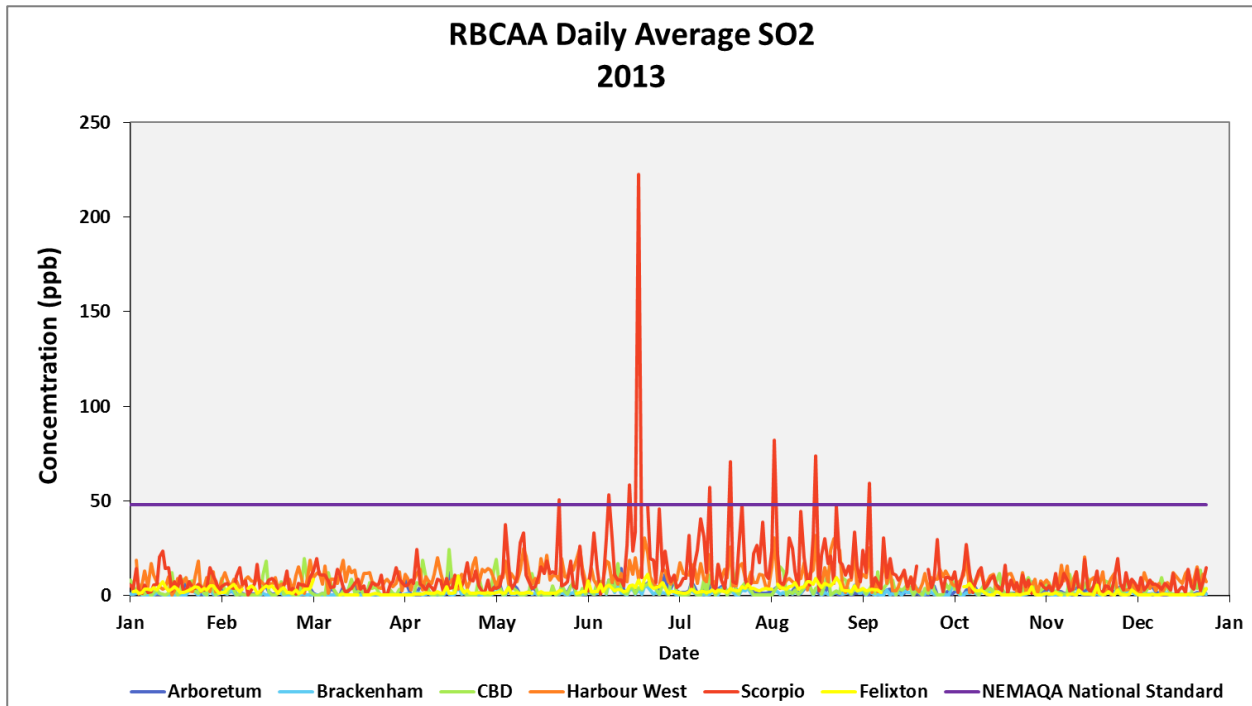
Figure 26: SO<sub>2</sub> daily average concentrations

The daily average SO<sub>2</sub> concentrations are shown below (Figure 26). A fire in Foskor's sulphur store on 22 July 2013 resulted in exceedances between 17:30 and 19:30 that day. Subsequent peaks between July and September were apportioned to BHP Billiton (Hillside).

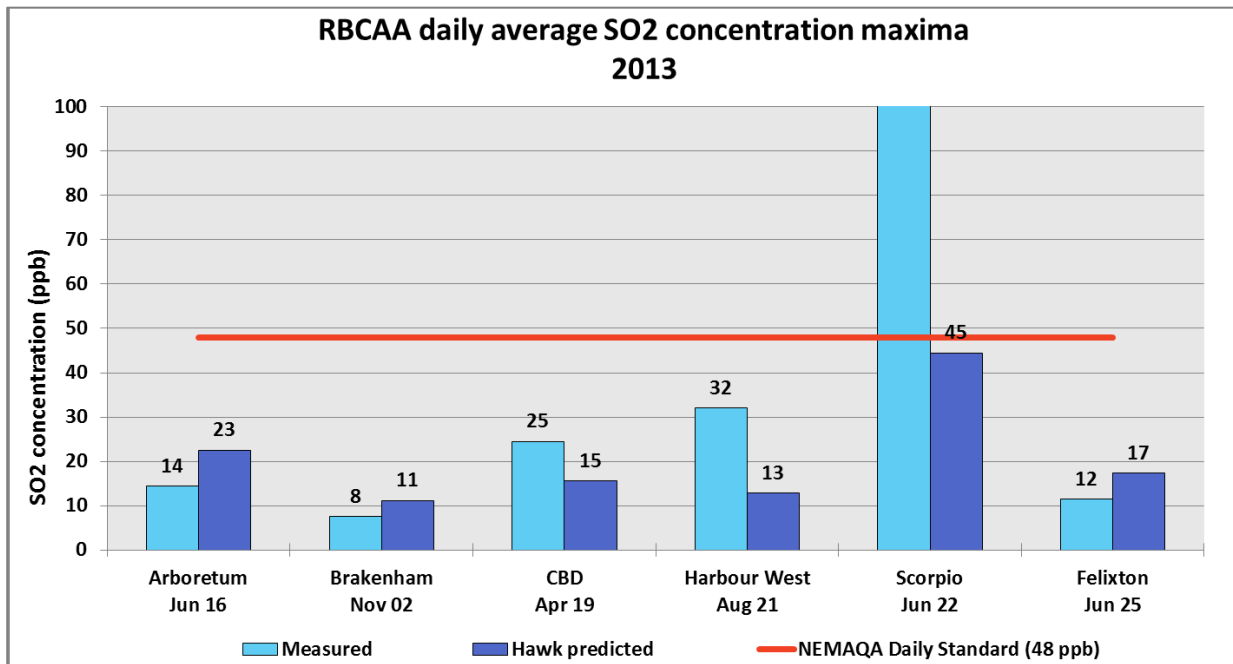
Figure 27: Daily average SO<sub>2</sub> concentration and prediction

Note: Under predictions may indicate higher than normal emissions for the time period concerned.

All daily average predicted values were within accepted dispersion modelling norms (-50% to 200%) with the exception of Harbour West and Scorpio which were under-predicted. Compared to the measurements, the predicted values at Arboretum, Brackenham and Felixton were higher; and CBD, Harbour West and Scorpio lower (Figure 27).

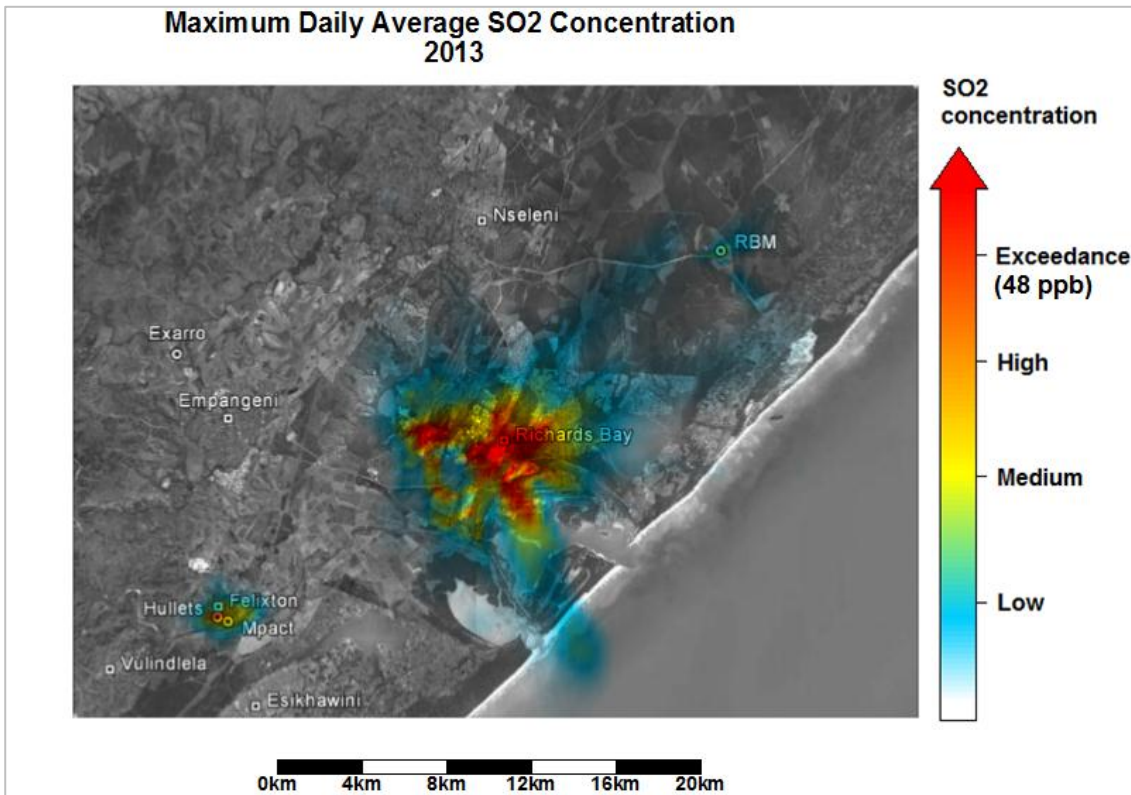
Figure 28: Maximum predicted daily average SO<sub>2</sub> concentration (regional map)

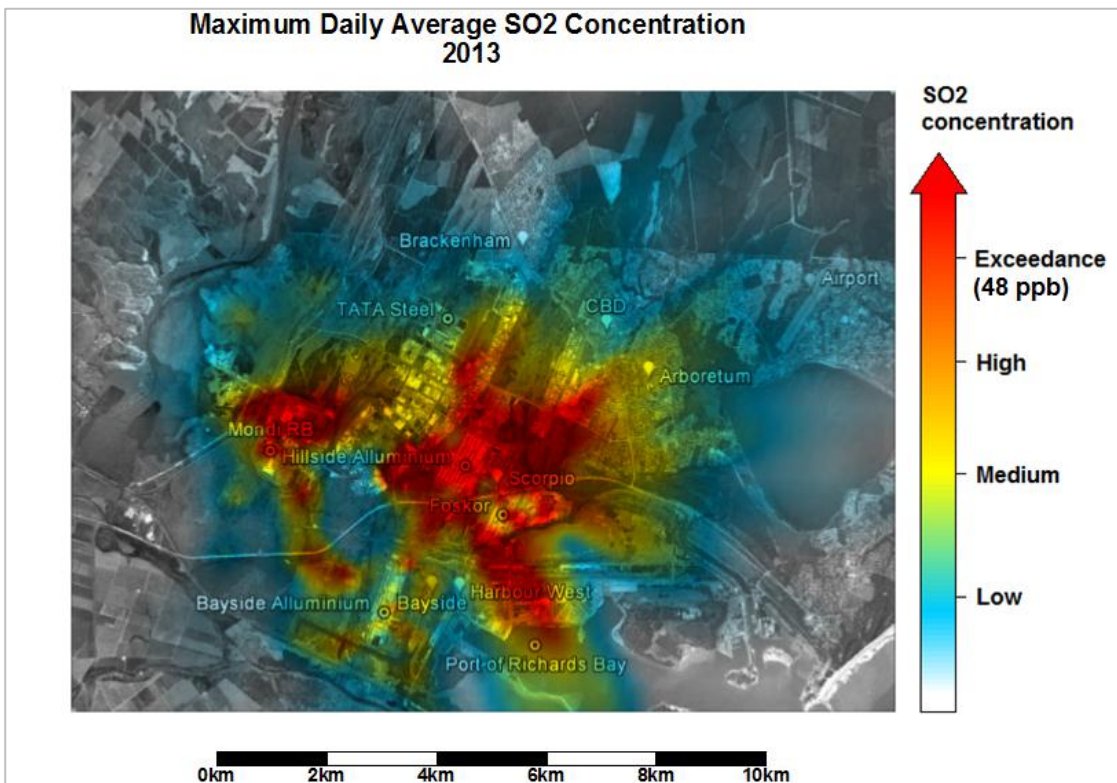
Figure 29: Maximum predicted daily average SO<sub>2</sub> concentration (Richards Bay map)

- Regional (Figure 16);
- Richards Bay (Figure 29);
- Felixton (Figure 30); and
- RBM (Figure 31).

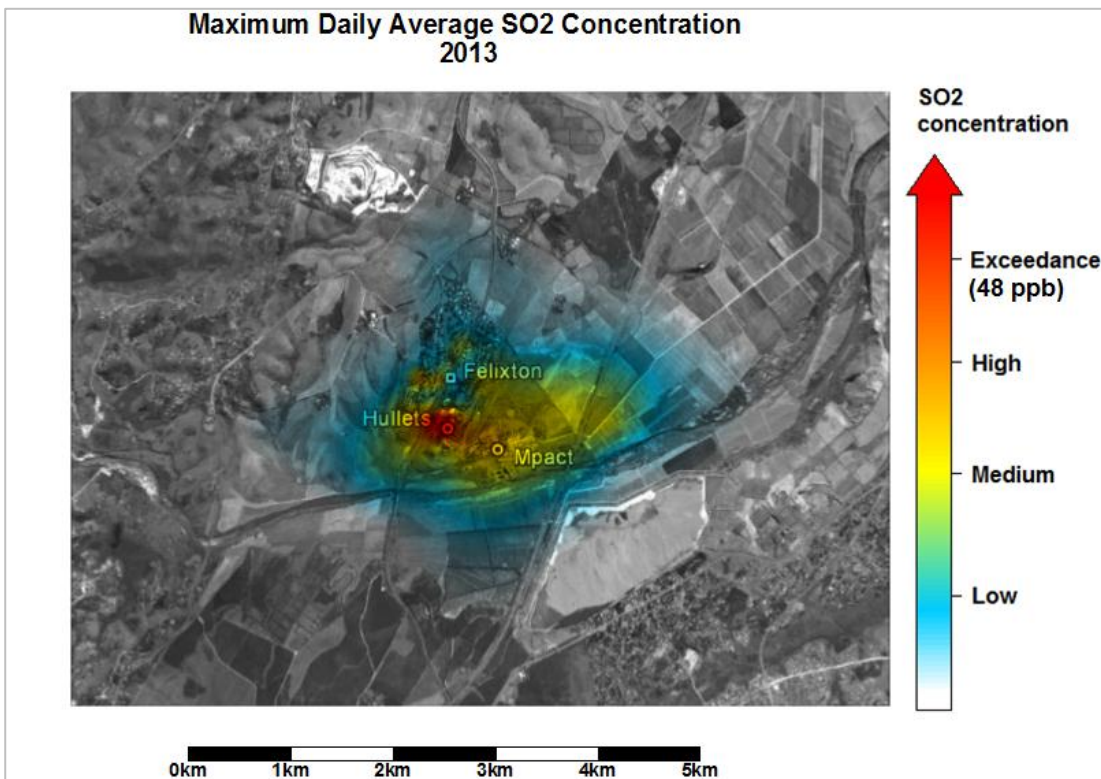
Figure 30: Maximum predicted daily average SO<sub>2</sub> concentration (Felixton map)

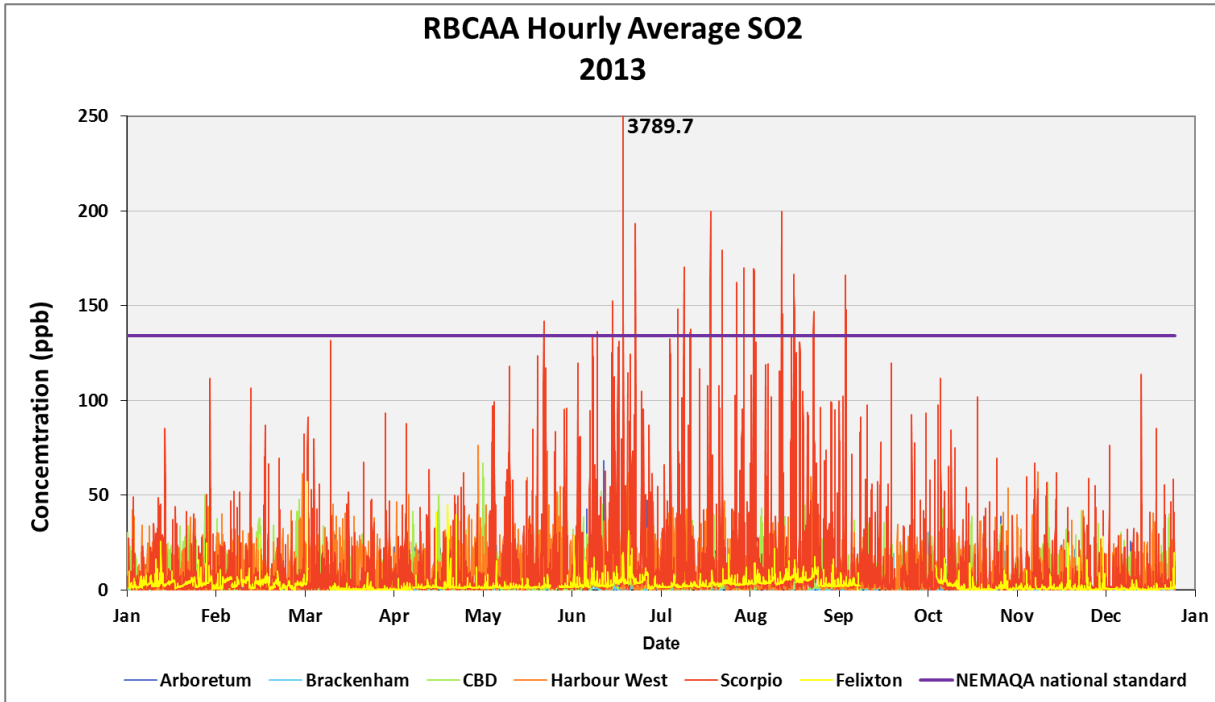
Figure 32: SO<sub>2</sub> hourly average concentrations

Hourly average SO<sub>2</sub> concentrations are shown below (Figure 32). A fire in Foskor's sulphur store on 22 July 2013 resulted in exceedances between 17:30 and 19:30 that day. Subsequent exceedances between July and September were apportioned to BHP Billiton (Hillside).

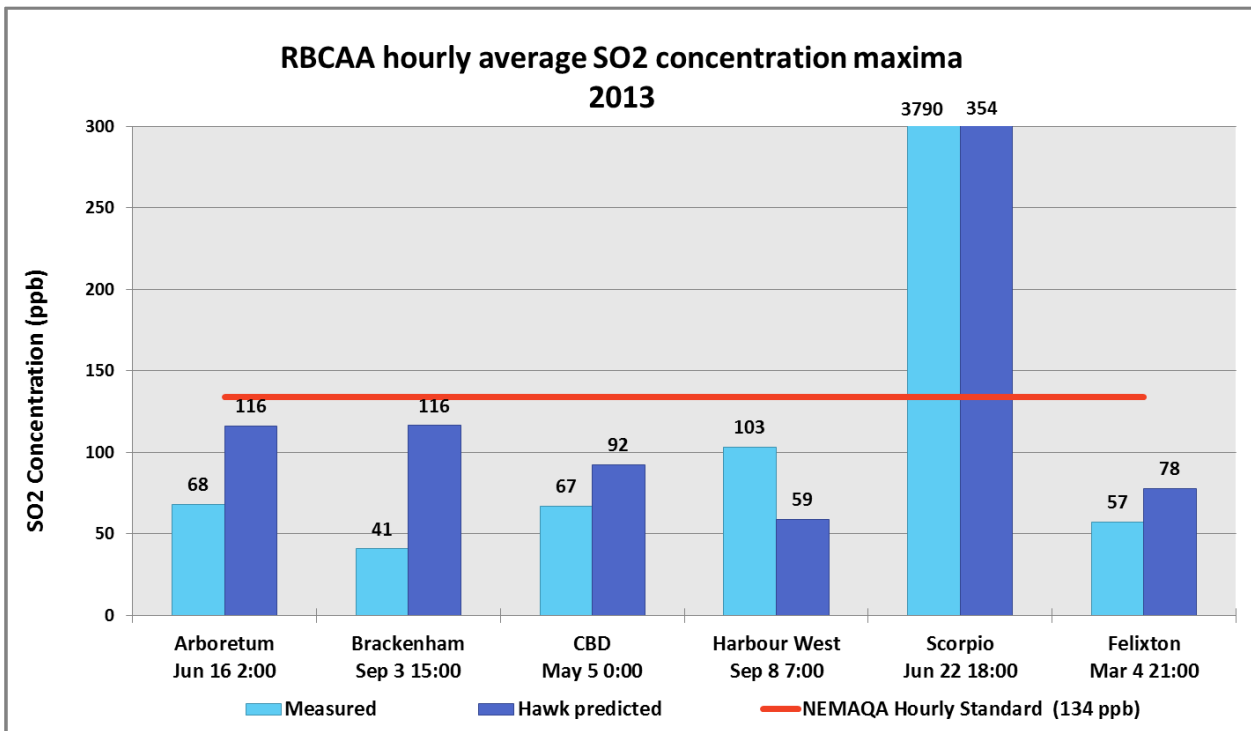
Figure 33: Hourly average SO<sub>2</sub> concentration and prediction

Note: The over-predictions for short term averages (hourly and 10 minute) at Arboretum and Brackenheim are under investigation.

All hourly average predicted values were within accepted dispersion modelling norms (-50% to 200%) with the exception of Scorpio which was under-predicted. Compared to the measurements, the predicted values at Harbour West and Scorpio were lower; and Arboretum, Brackenheim, CBD and Felixton higher (Figure 33).

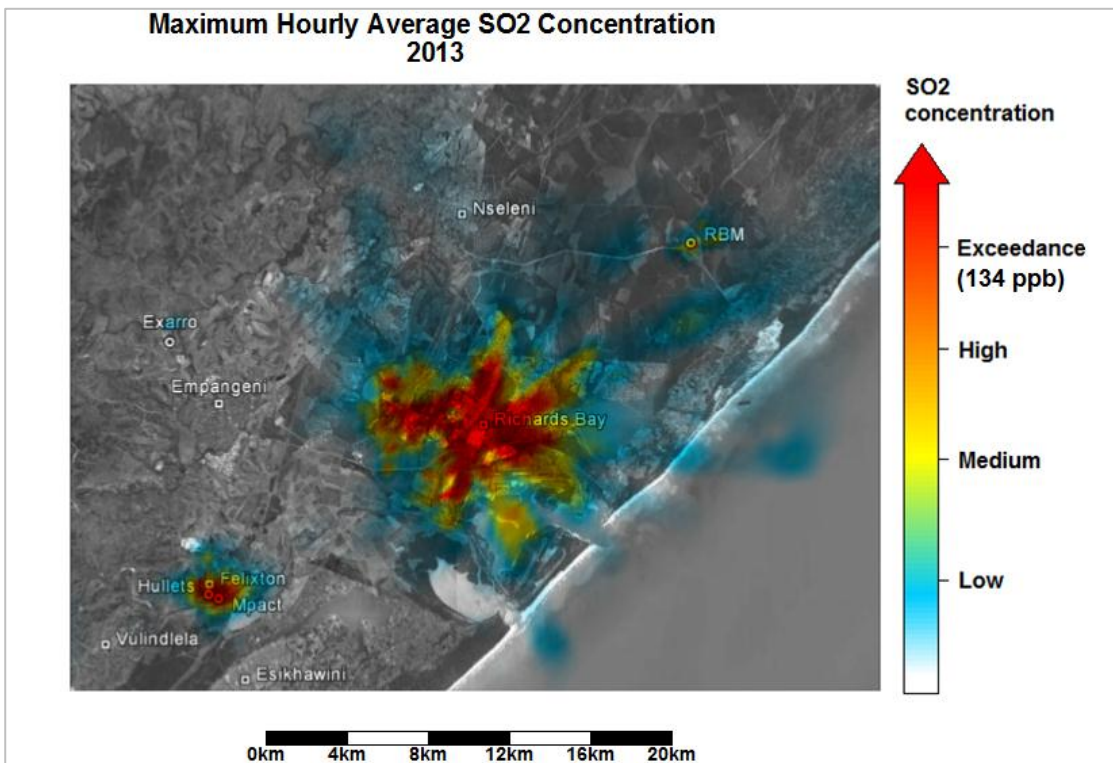
Figure 34: Maximum predicted hourly average SO<sub>2</sub> concentration (regional map)

- Regional (Figure 34);
- Richards Bay (Figure 35);
- Felixton (Figure 36); and
- RBM (Figure 37).

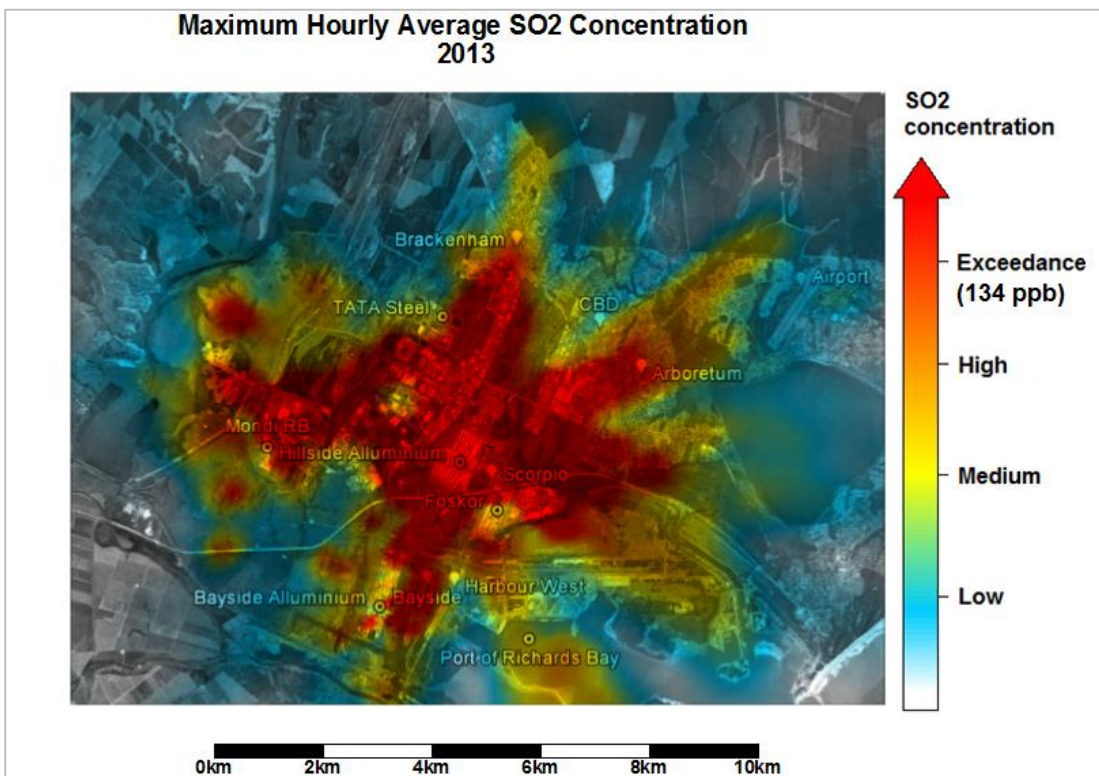
Figure 35: Maximum predicted hourly average SO<sub>2</sub> concentration (Richards Bay map)

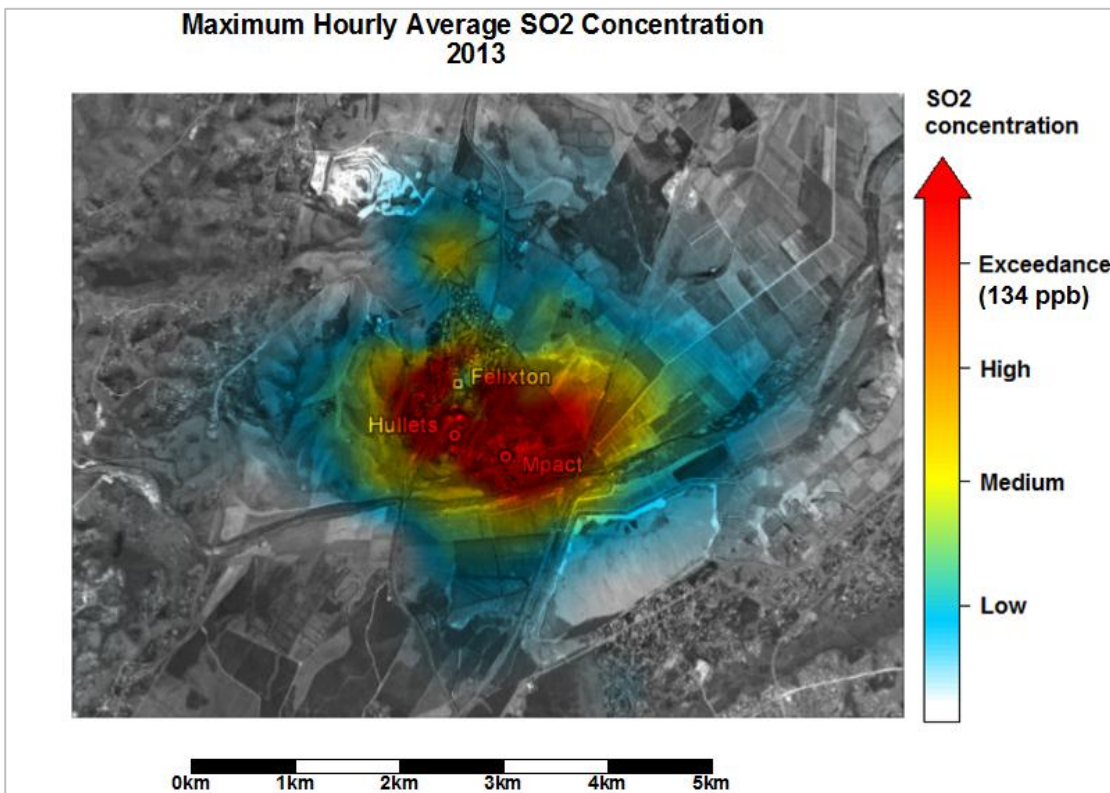
Figure 36: Maximum predicted hourly average SO<sub>2</sub> concentration (Felixton map)

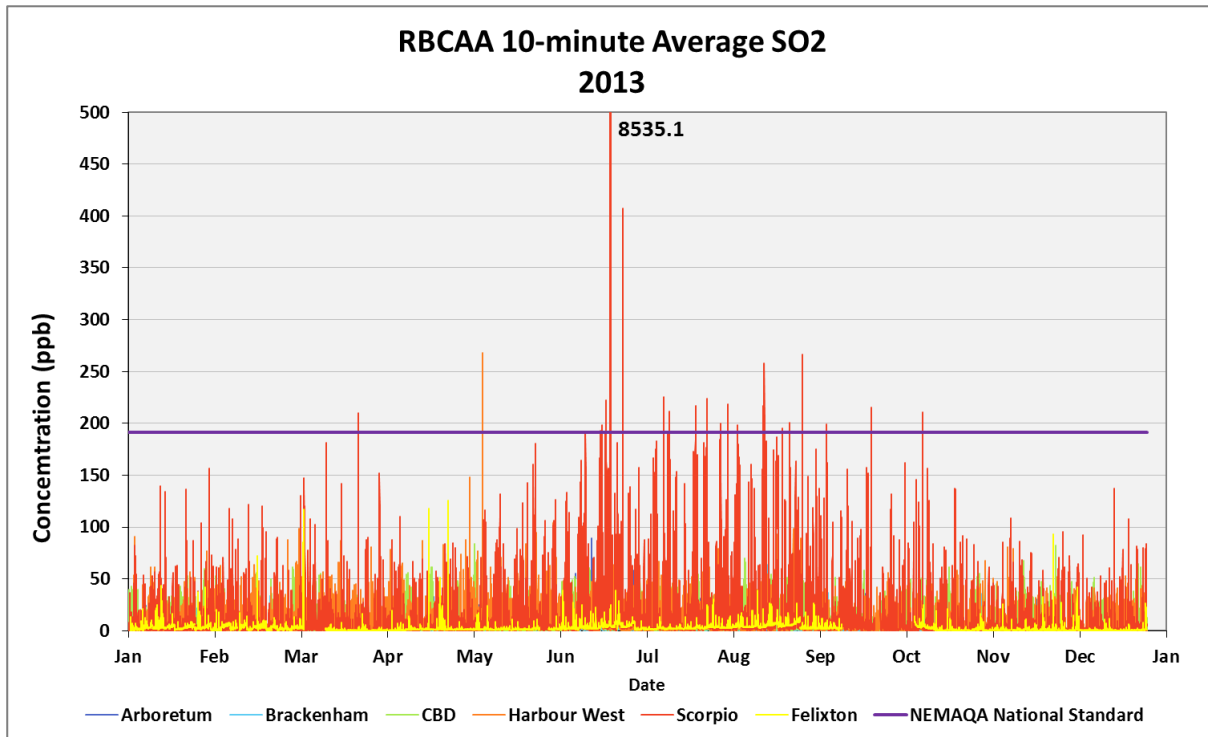
Figure 38: SO<sub>2</sub> 10 minute average concentrations

The 10-minute average SO<sub>2</sub> concentrations are shown below (Figure 38). A fire in Foskor’s sulphur store on 22 July 2013 resulted in exceedances between 17:30 and 19:30 that day. Subsequent peaks between July and September were apportioned to BHP Billiton (Hillside).
