ANNUAL REPORT FOR 2013

# Annual Ambient Air Quality Monitoring and Dispersion Modelling

Richards Bay Clean Air Association (RBCAA)  
Sandy Camminga

**Report Number.** 12614846-12632-17

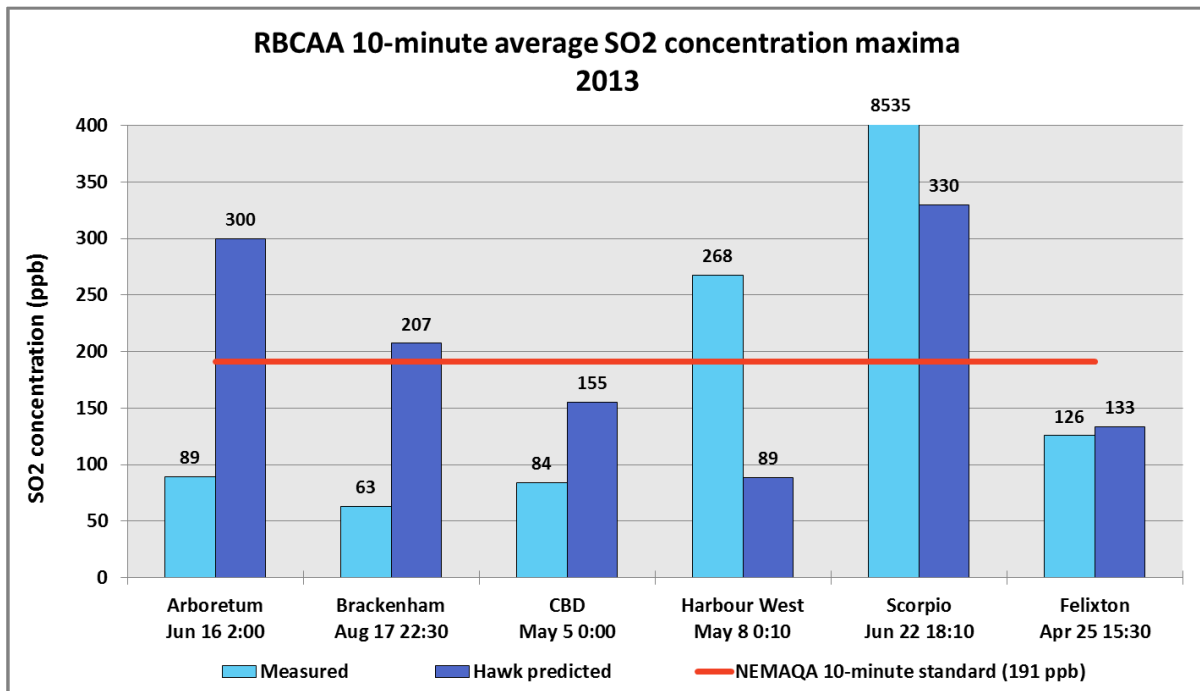
Figure 39: 10-minute average SO<sub>2</sub> concentration and prediction

CBD and Felixton 10-minute average predicted values were within accepted dispersion modelling norms (-50% to 200%). Arboretum and Brackenheim values were over predicted while Harbour West and Scorpio were under-predicted. Compared to the measurements, the predicted values at Harbour West and Scorpio were lower; and Arboretum, Brackenheim and CBD higher (Figure 39).

Note: The over-predictions for short term averages (hourly and 10 minute) at Arboretum and Brackenheim are under investigation.

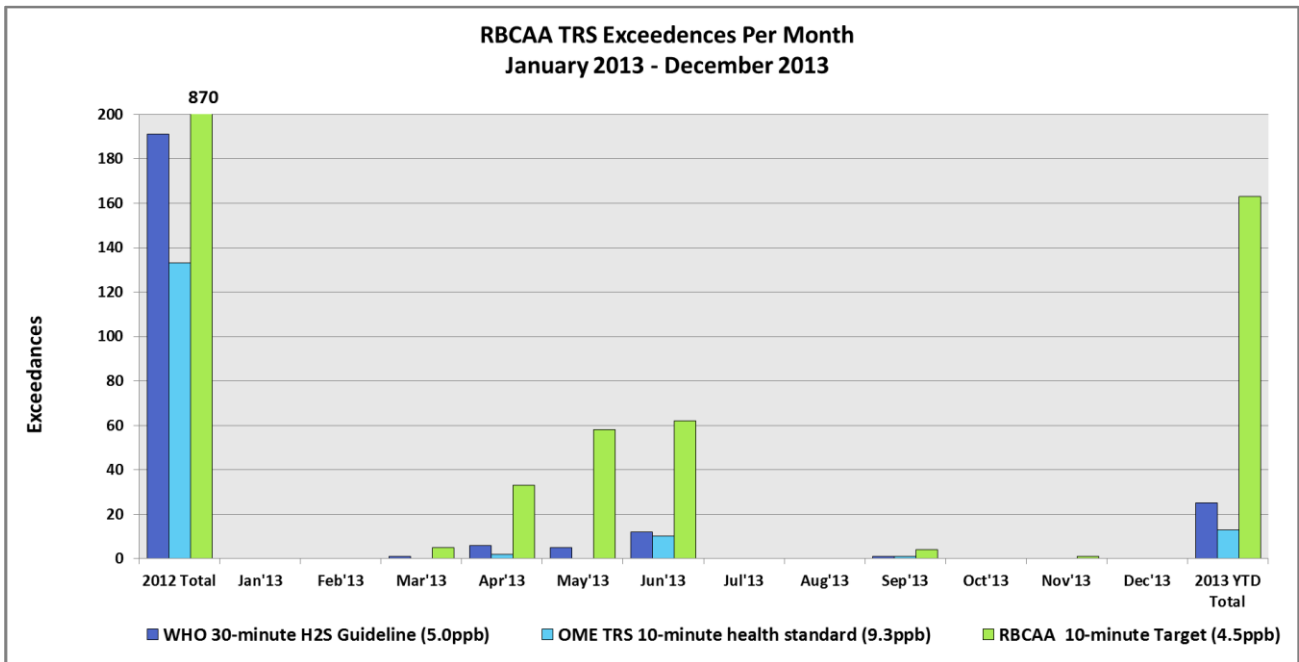
Figure 44: TRS exceedances for 2013.

Twenty five (25) exceedances of the WHO 30-minute  $H_2S$  Guideline (5.0ppb), thirteen (13) exceedances of the OME TRS 10-minute health standard (9.3ppb) and one hundred and sixty three (163) exceedances of the RBCAA 10-minute Target (4.5ppb) were recorded during 2013 (Figure 44)

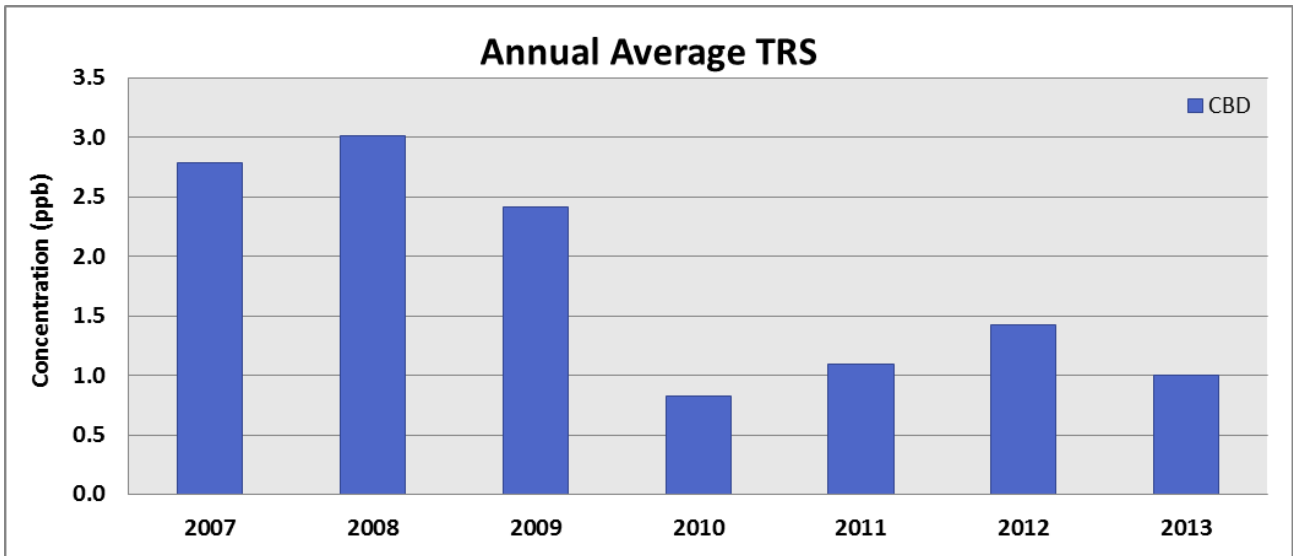
Figure 45: TRS annual average information.

Annual average TRS concentrations are illustrated in Figure 45. A marked decrease in annual average TRS concentrations is evident post 2009. Concentrations increased marginally 2012 and dropped subsequently in 2013. This is likely due to the success of Mondi's odour abatement programme.

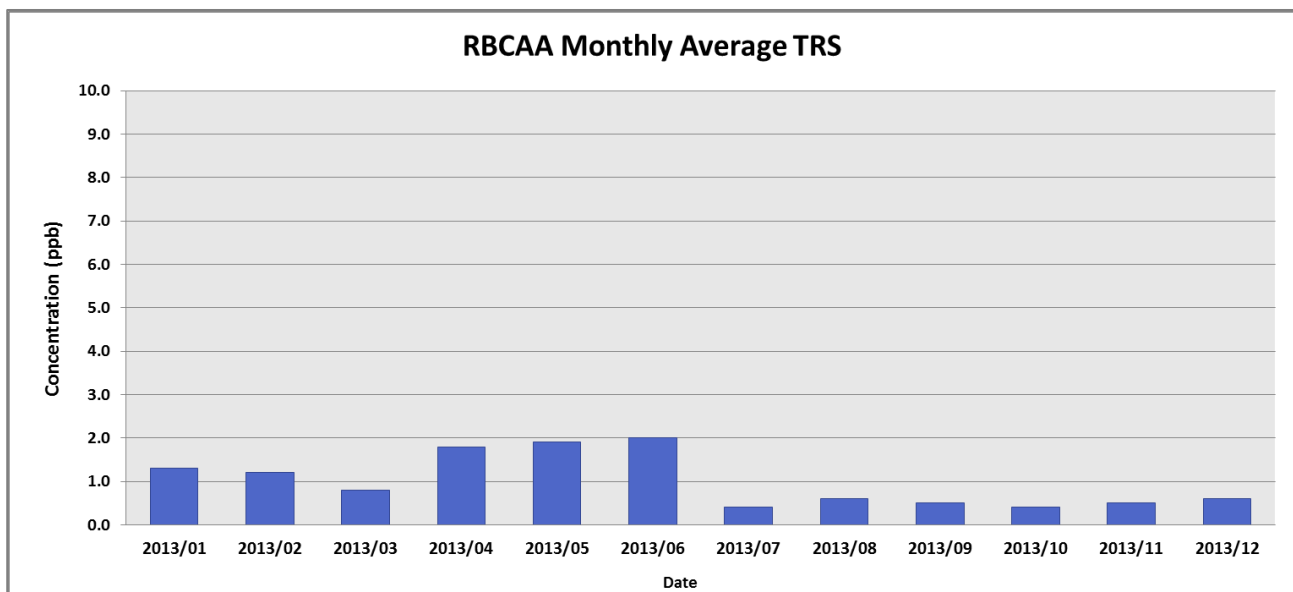
Figure 46: Seasonal trends in TRS (monthly average concentrations)

The seasonal trends for TRS concentrations in 2013 are provided in Figure 46. An over-all decreasing trend is noted in 2013, with the exception of marginally elevated levels recorded in April, May and June. Concentrations returned to baseline levels after the analyser was calibrated in June 2013 (please see **Error! Reference source not found.**).

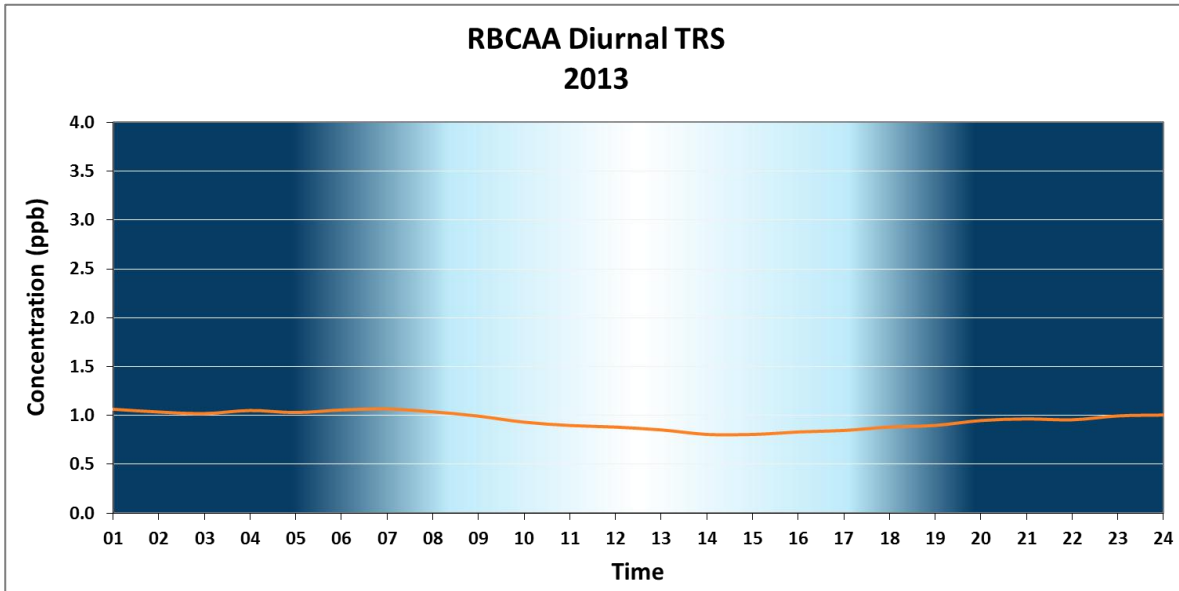
Figure 47: TRS diurnal trend

The diurnal TRS concentrations are shown below (Figure 47).

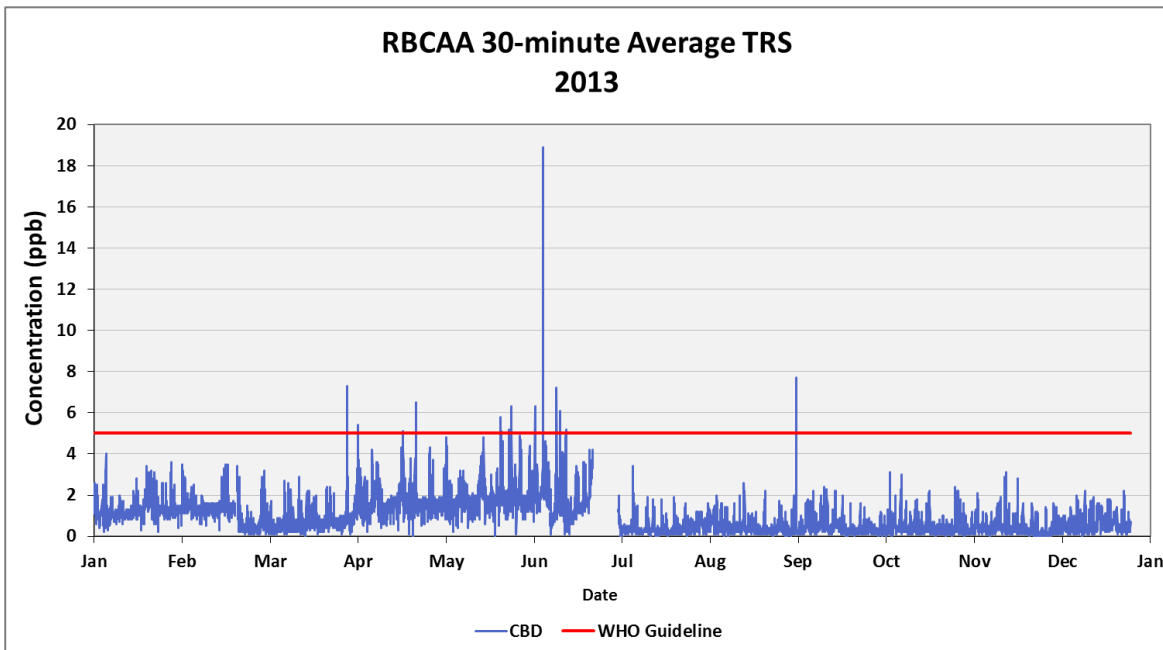
Figure 48: TRS 30-minute average concentration

The 30-minute average TRS trend at CBD is shown below (Figure 48). The cause of the 18.9ppb peak at midnight on 8 June 2013 remains unknown. No complaints were received in relation to this incident potentially due to the time at which it occurred. Data from 25 June 2013 until 4 July 2013 was invalidated due to a blocked SO<sub>2</sub> scrubber in the TRS converter causing skewed results (see APPENDIX B for further details).

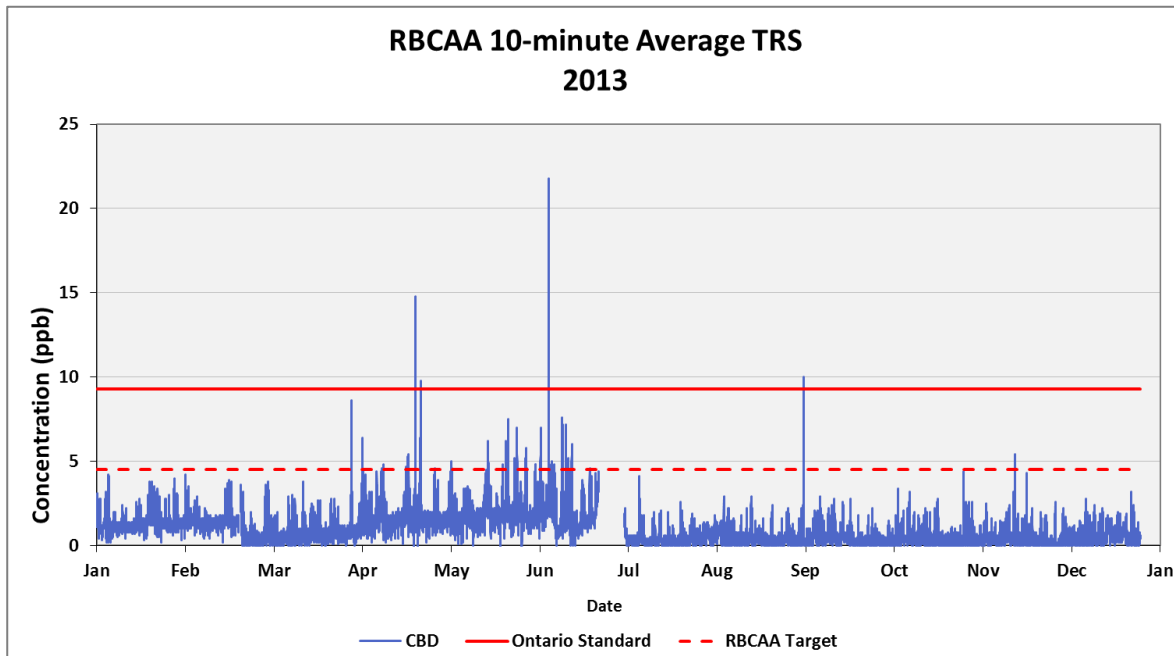
Figure 49: TRS 10-minute average concentrations

The 10-minute average TRS trend is shown below (Figure 49).
